LIMITED ASBESTOS SURVEY REPORT
King Hall – Boiler Room

Date Prepared: April 5, 2018

King Hall – Boiler Room

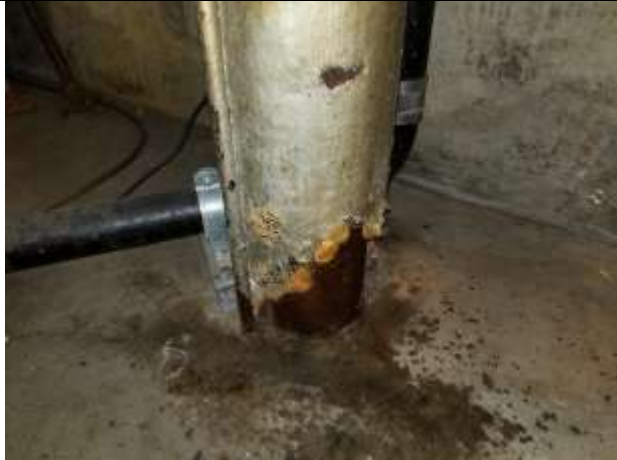
Non- ACM Pipe insulation	Asbestos Containing Insulation

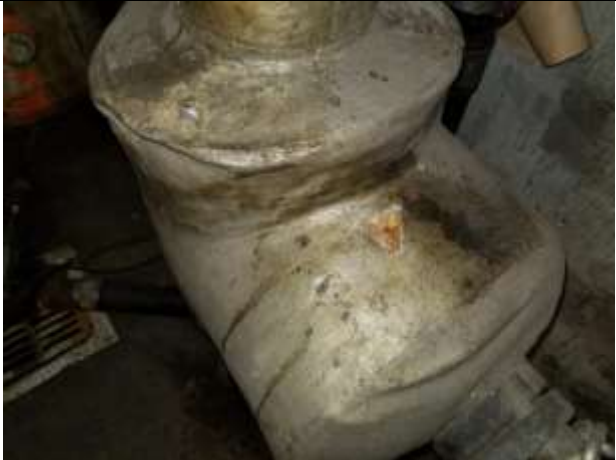
Homogeneous Material	Location	Lab Sample Numbers	Asbestos detected	Quantity
Pipe Insulation (TSI)	Boiler Room	321807578-0001 321807578-0002 321807578-0003	Chrysotile 30% (Elbow only)	10 LF

Asbestos containing materials will be impacted by the renovation activities. Removal and disposal of Asbestos containing pipe insulation must be performed by a California Licensed asbestos abatement contractor, in accordance with all applicable regulations, including but not limited to, 29 CFR 1926.1101 (OSHA), 40 CFR 763 (ASHERA), 40 CFR Part 61 (NESHAPS) and 8 CAC 1529 (Cal/OSHA Asbestos), including mandatory and non-mandatory appendices as applicable, and Local Air Quality Management District regulations (SCAQMD 1403).

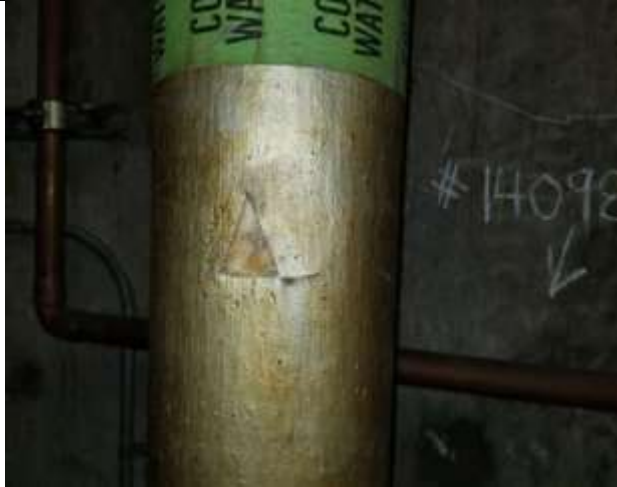
Non-ACM raiser insulation	General view of boiler room
