TO: California State University Los Angeles
Arthur Lopez
Facilities Project Supervisor
Facilities Services

LIMITED ASBESTOS SURVEY REPORT
CSULA - King Hall (Rooms 4061 & 4056)
5151 State University Drive
Los Angeles, CA 90032

Date Prepared: February 1, 2023

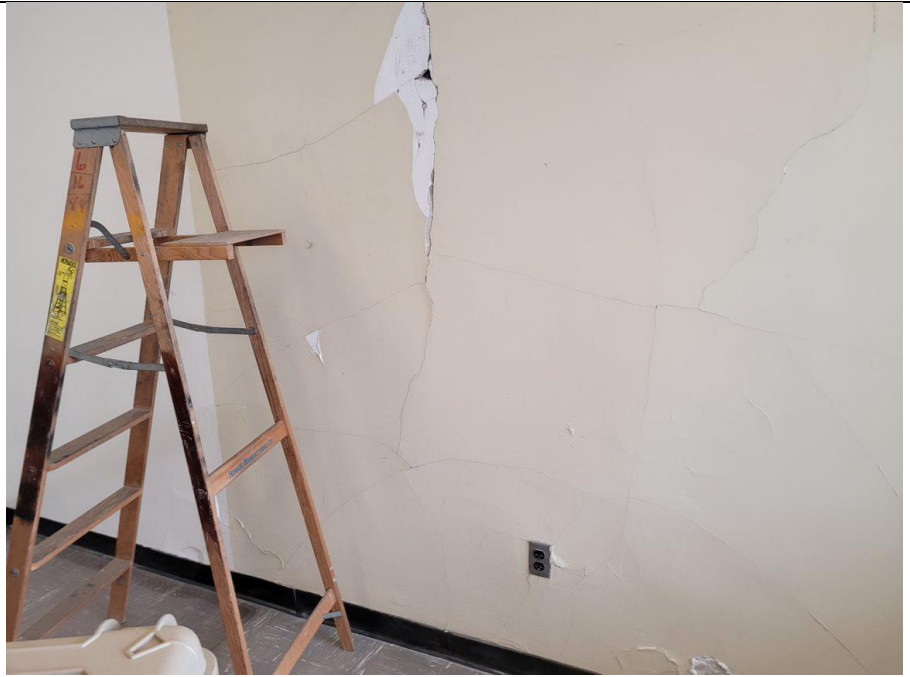
Picture #1

Room 4061
Plaster wall
Asbestos - None detected

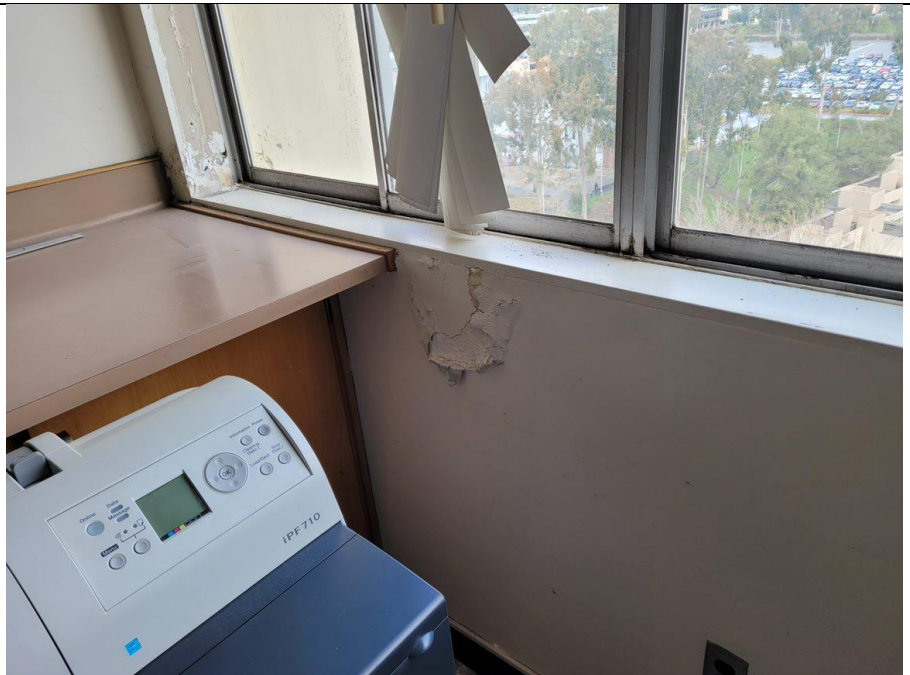
Picture #2

Room 4056
Finish compound
Asbestos – None Detected
