TO: ROBERT SALERNO  
FACILITIES PROJECT SUPERVISOR  
CALIFORNIA STATE UNIVERSITY  
5151 STATE UNIVERSITY DRIVE  
LOS ANGELES, CA 90032

**LIMITED ASBESTOS SURVEY REPORT**  
**King Hall Rm. C129**

Date Prepared: November 14, 2018

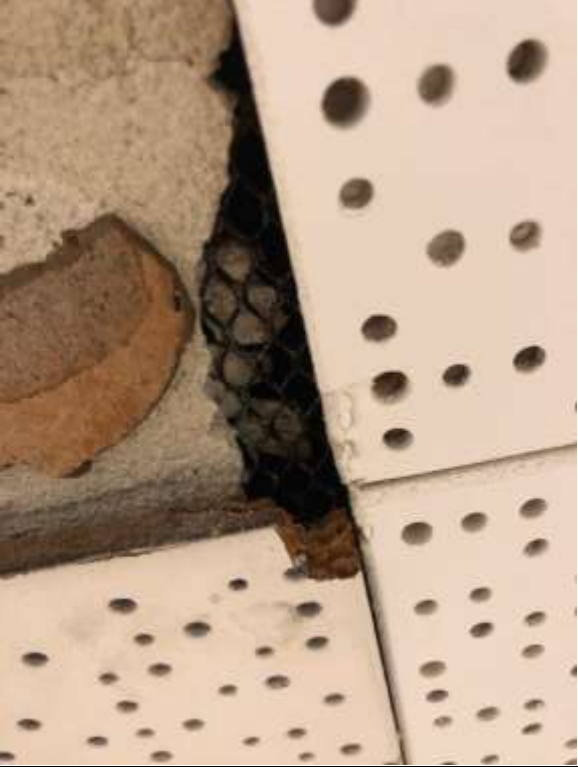
King Hall C129	
<p>Photo #1</p> <p>Hallway outside Room C129</p> <p>Non-ACM: Plaster 1x1 Ceiling tiles Brown adhesive</p>

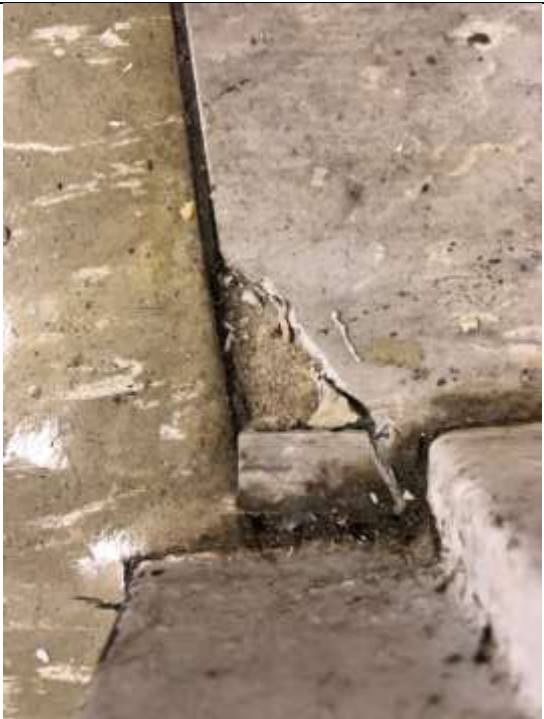
<p>Photo #2</p> <p>Hallway outside room C129</p> <p>ACM black mastic on 12x12 VFT (multi-layer)</p>

Removal and disposal of Asbestos containing **VFT 12"x12" Grey w/Black Mastic** must be performed by a California Licensed Asbestos Abatement Contractor, in accordance with all applicable regulations, including but not limited to, 29 CFR 1926.1101 (OSHA), 40 CFR 763 (ASHERA), 40 CFR Part 61 (NESHAPS) and 8 CAC 1529 (Cal/OSHA Asbestos), including mandatory and non-mandatory appendices as applicable, and Local Air Quality Management District regulations (SCAQMD 1403).

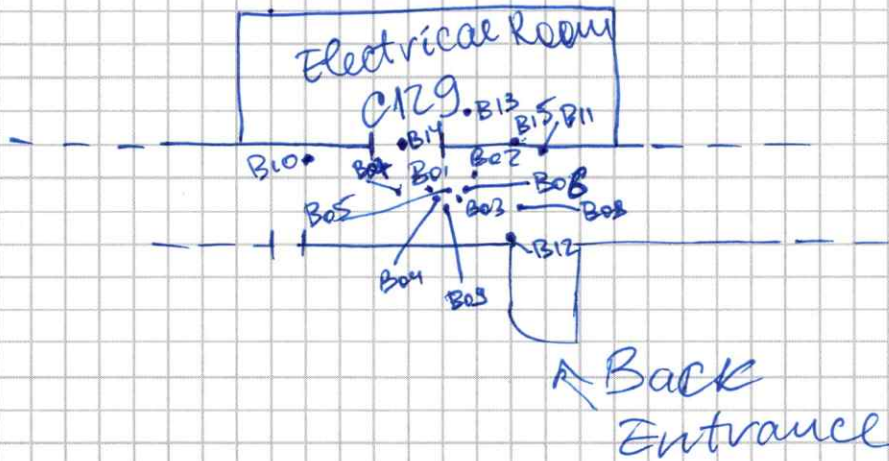
Project Name: Asbestos Survey.

Project Address: Calstate- LA , King Hall Building.
