LIMITED ASBESTOS SURVEY REPORT
California State University Los Angeles
King Hall – Room 1064
5151 State University Drive
Los Angeles, CA 90032

Date Prepared: August 12, 2019

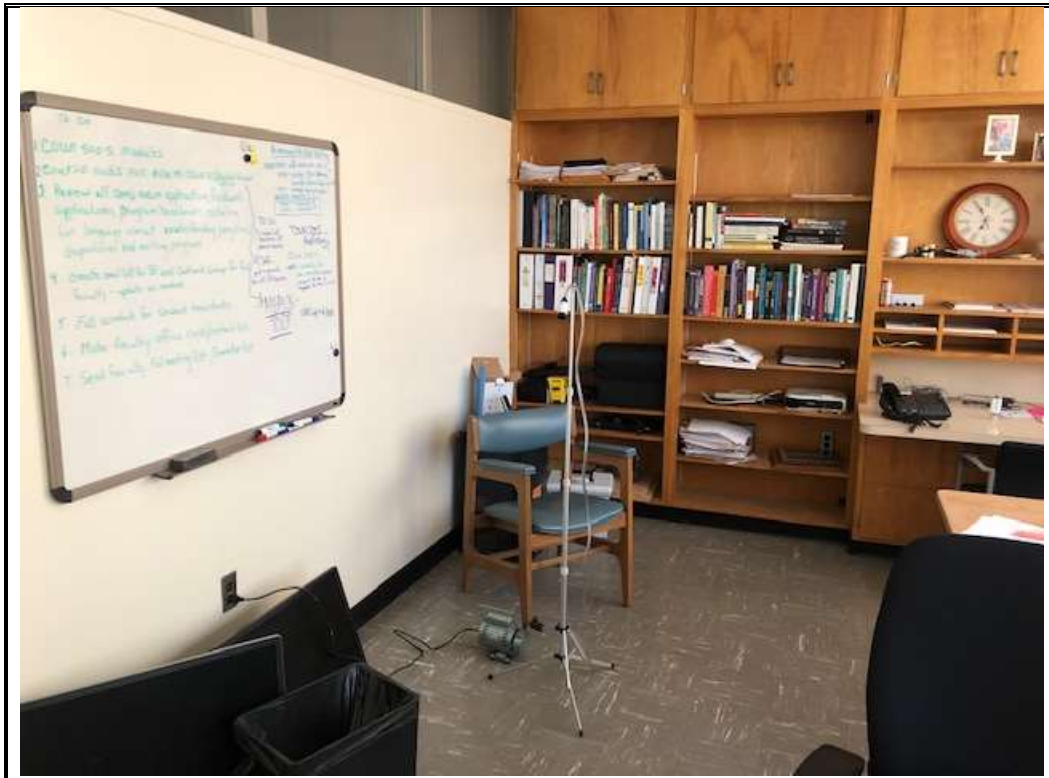
Asbestos containing materials identified the King Hall - Room 1064. The Vinyl floor tile mastic asbestos content is 2% Chrysotile, these materials is in good condition does not constitute a health hazard if left undisturbed and well maintained.

Asbestos containing black mastic on 9"x9" vinyl floor tile

Removal and disposal of Asbestos containing **Floor VCT Tile Mastic** must be performed by a California Licensed Asbestos Abatement Contractor, in accordance with all applicable regulations, including but not limited to, 29 CFR 1926.1101 (OSHA), 40 CFR 763 (AHERA), 40 CFR Part 61 (NESHAPS) and 8 CAC 1529 (Cal/OSHA Asbestos), including mandatory and non-mandatory appendices as applicable, and Local Air Quality Management District regulations (SCAQMD 1403).
