Re: Asbestos Ambient Air Monitoring
California State University Los Angeles
King Hall – 2nd Floor – Rooms: D2078, D2078E, & D2708F
5151 State University Dr.
Los Angeles, CA 90032

GETC Project No.: **E225-125**

SCHEMATIC

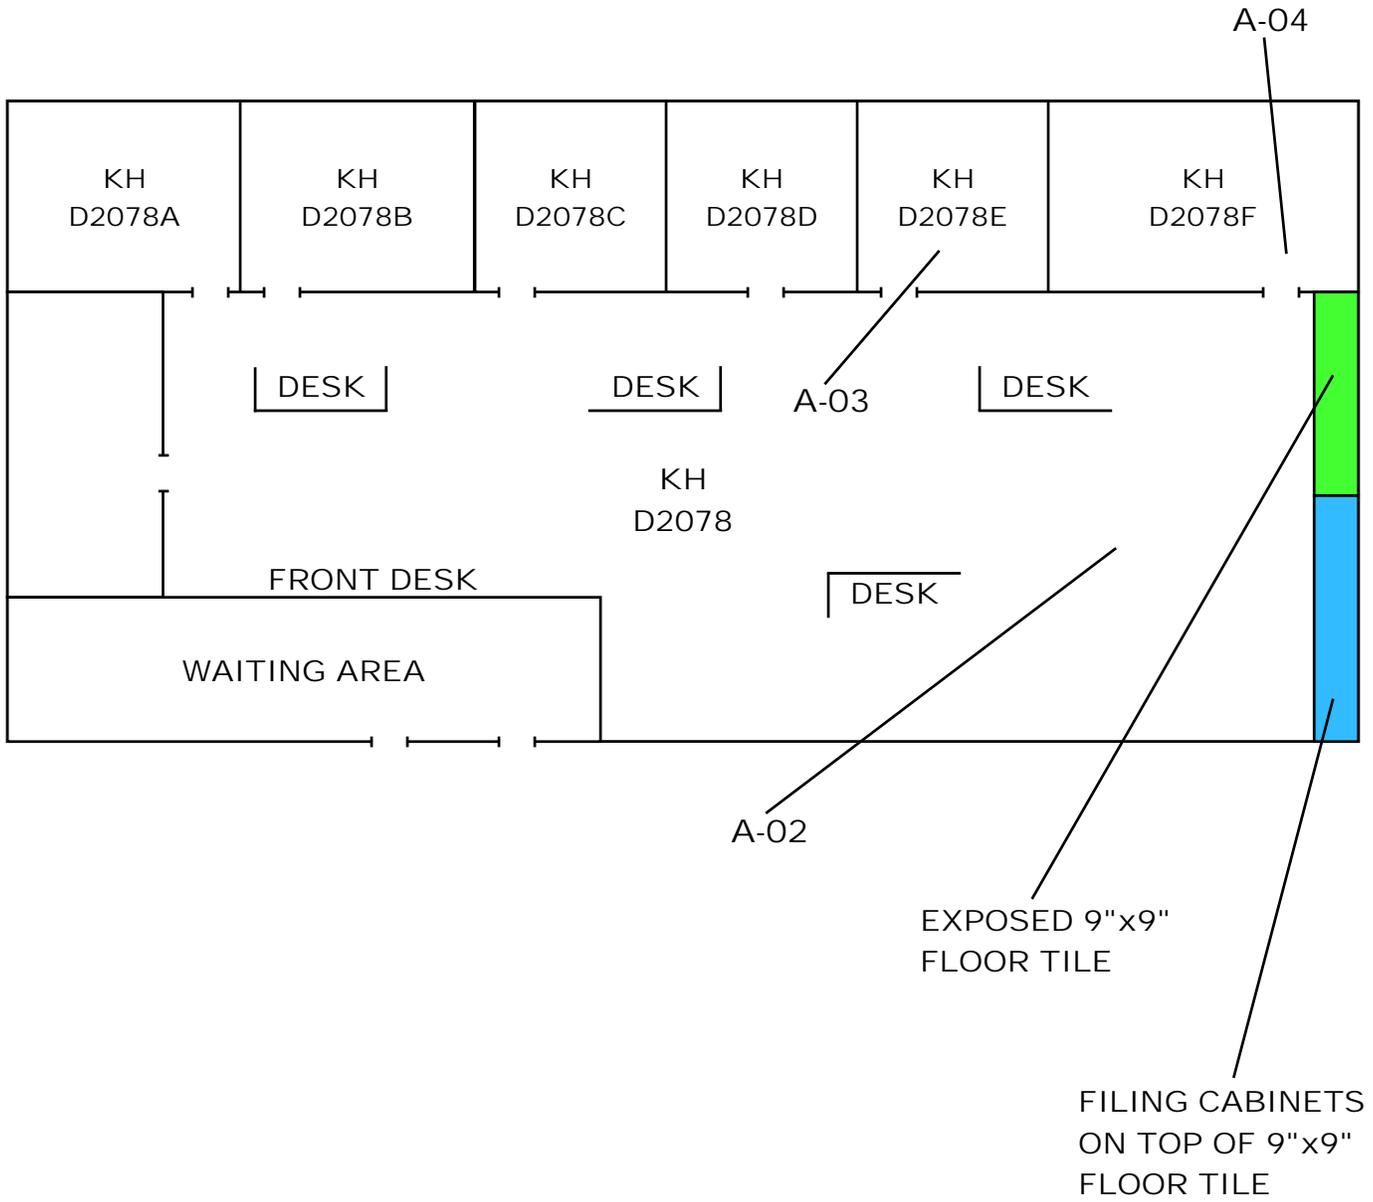
Ambient Air Samples were collected from several areas throughout King Hall – 2nd Floor – Rooms: D2078, D2078E, & D2708F (See diagram for locations). All samples were analyzed using Transmission Electron Microscopy (TEM) using the National Institute of Occupational Safety and Health (NIOSH) Method 7402 which determines specific asbestos structure concentration. The ambient air sample results indicate that Samples #A-03 & #A-04 have no structures detected. However, one (1) Structure of Chrysotile was detected in Sample #A-02 but is below the Environmental Protection Agency (EPA) Clearance Criteria of 70 structures/millimeter squared (70 s/mm²). Area is approved for re-occupancy.
