Re: Microbiological Ambient Air Sampling – Monitoring  
**Biological Sciences Building**  
**1st Floor – 3rd Floor – Unaffected Offices Within the Enclosed Areas**  
5151 State University Dr.  
Los Angeles, CA 90032

**GETC Project No. E225-281**

Global Environmental Training & Consulting, Inc. (GETC) was retained by the California State University, Los Angeles (CSULA) to conduct Microbiological Ambient Air Sampling at the Biological Sciences Building – 1st Floor – 3rd Floor located at 5151 State University Dr., in Los Angeles, California.

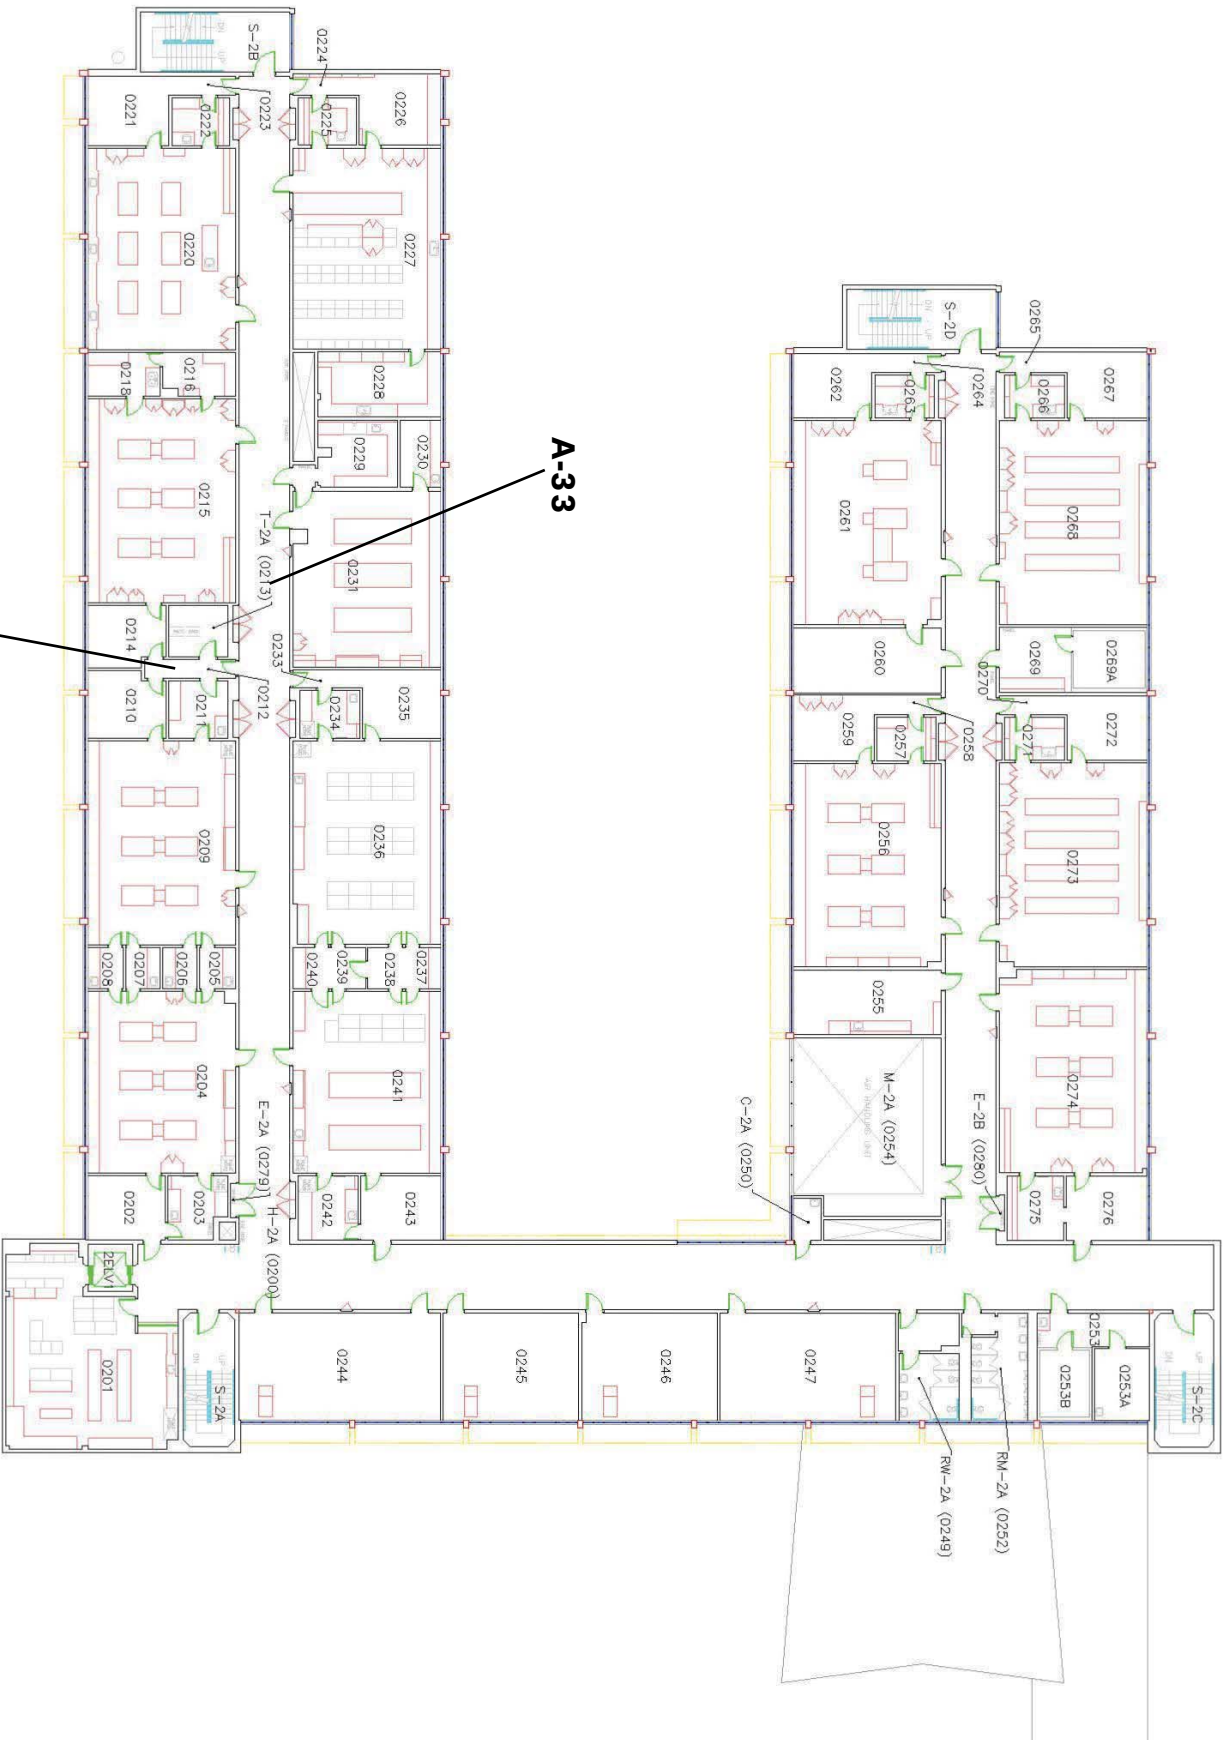
# BIOLOGICAL SCIENCES SECOND FLOOR

| SAMPLE<br>№ | SPORES / m <sup>3</sup> | | | | | | | | | | TOTAL NUMBERS<br>SPORES/m <sup>3</sup> |
|---|---|---|---|---|---|---|---|---|---|---|---|
| <b>A-33</b><br>2 <sup>nd</sup> Floor Corridor Next to<br>Room 231 | - | - | 13 | - | 13 | - | - | 7 | - | - | <u><b>33</b></u> |
| <b>A-34</b><br>2 <sup>nd</sup> Floor Room 212 | - | - | 7 | - | 20 | - | - | - | - | - | <u><b>27</b></u> |

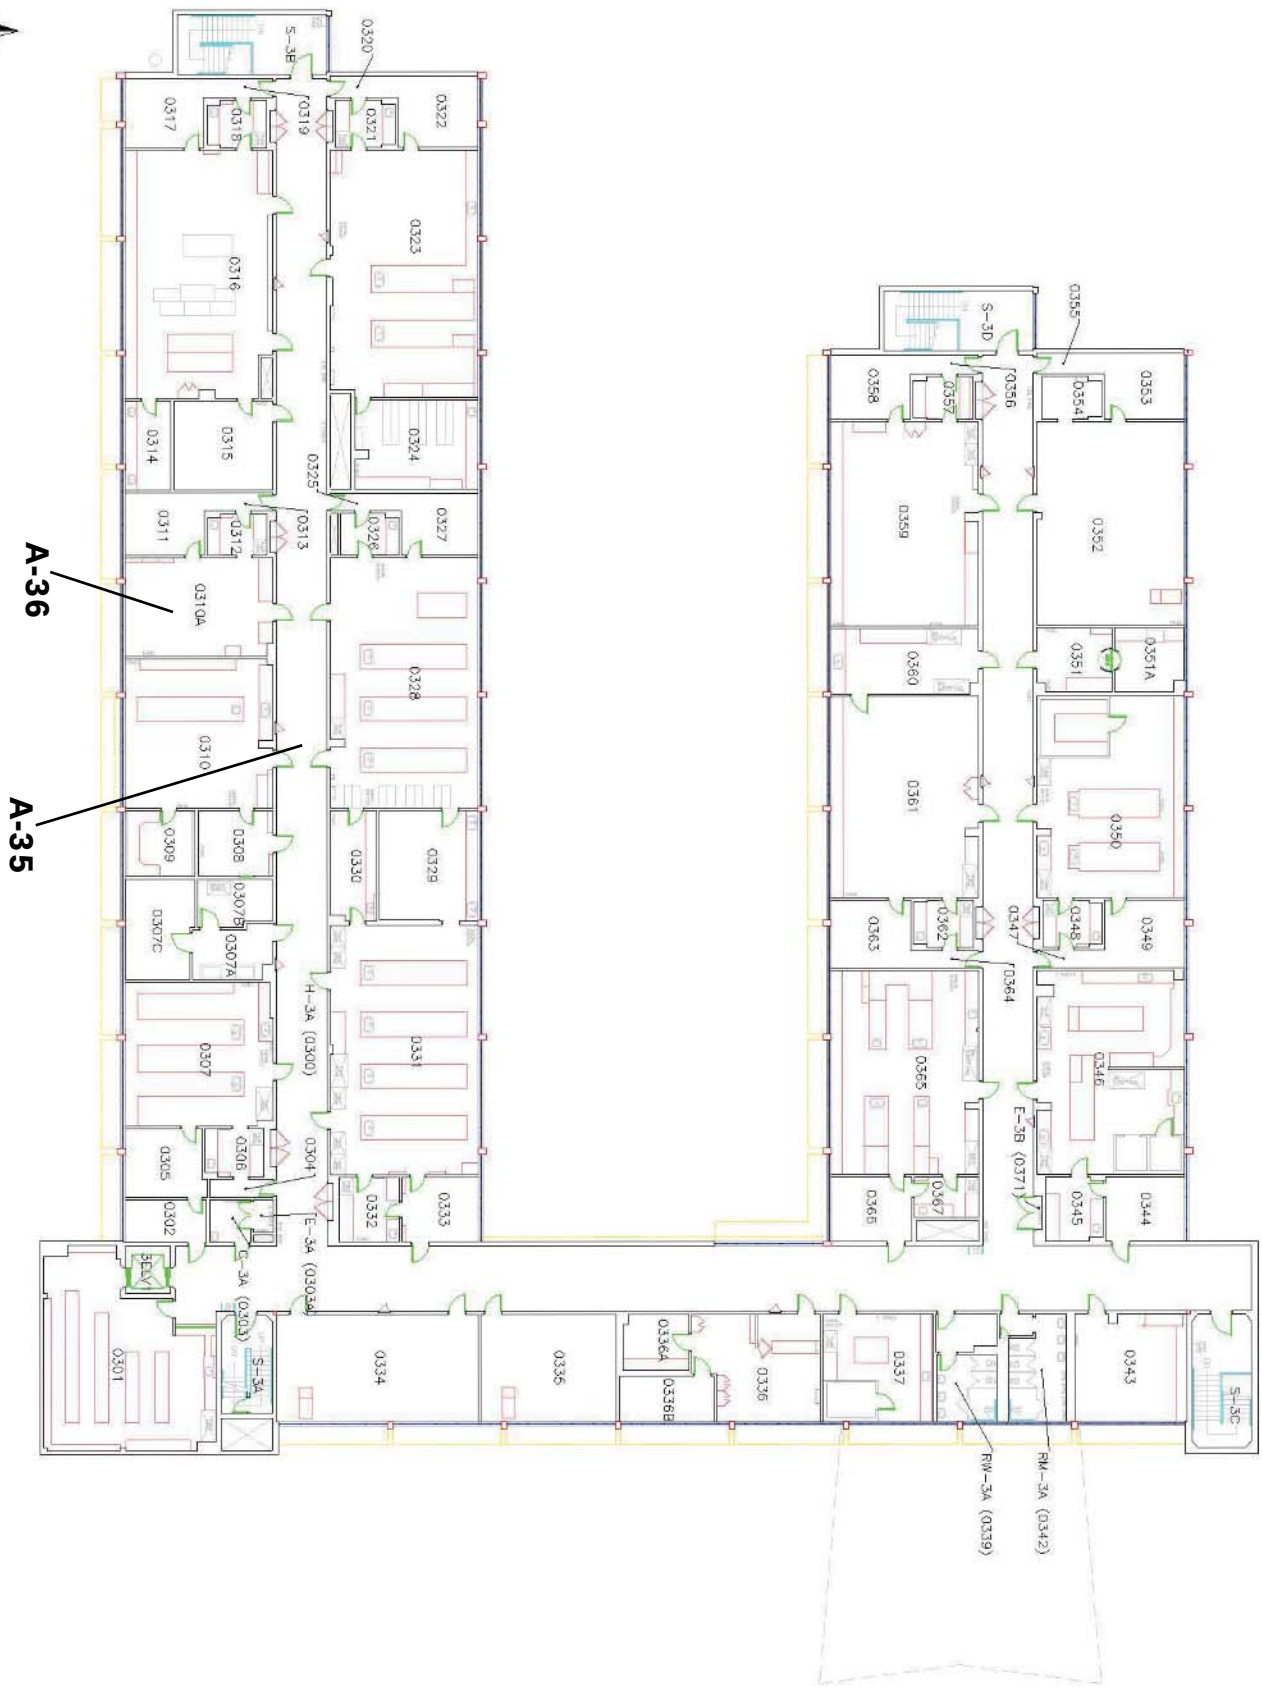
**BIOLOGICAL SCIENCES  
THIRD FLOOR**

| SAMPLE<br>№ | SPORES / m <sup>3</sup> | | | | | | | | | | TOTAL NUMBERS<br>SPORES/m <sup>3</sup> |
|---|---|---|---|---|---|---|---|---|---|---|---|
| <b>A-35</b><br>3 <sup>rd</sup> Floor Corridor Next to<br>Room 310 | - | - | 7 | - | 13 | - | - | - | - | - | <u><b>20</b></u> |
| <b>A-36</b><br>3 <sup>rd</sup> Floor Room 310A | - | - | - | - | 13 | - | - | - | - | - | <u><b>13</b></u> |
