August 16, 2024

RE: ASBESTOS AMBIENT AIR SAMPLING
California State University Los Angeles (CSULA)
King Hall
5151 State University Drive
Los Angeles, CA 90032

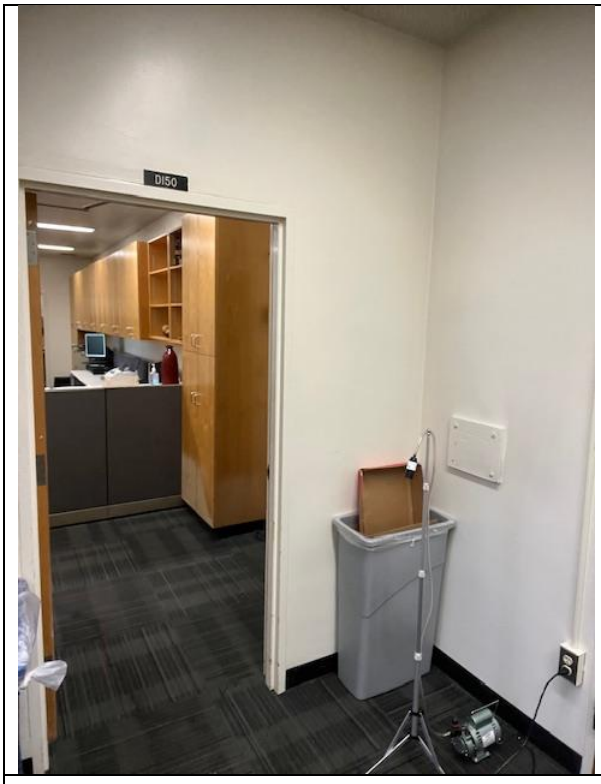
Basement D150 – Air samples below EPA levels	Basement B114 – Air samples below EPA levels

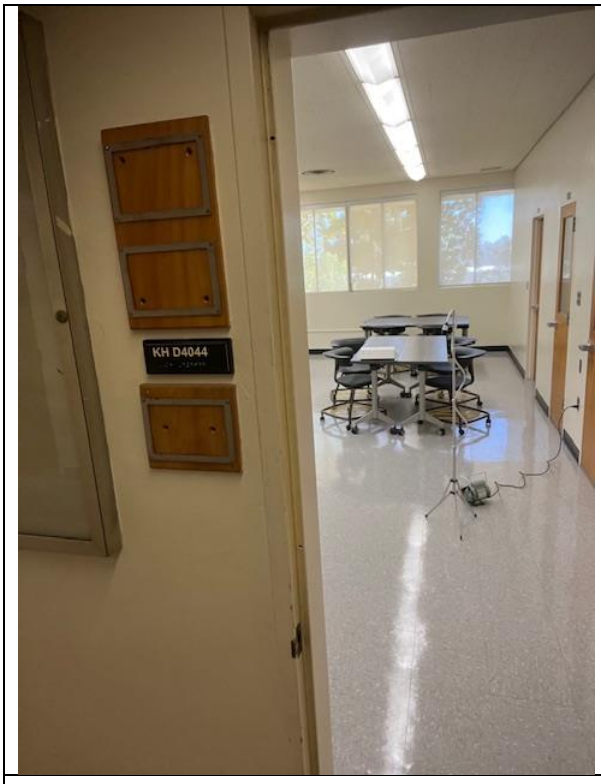
4th Floor Classroom D4044 – Air samples below EPA levels	4th Floor Classroom C4075 – Air samples below EPA levels
