TO: ROBERT SALERNO FACILITIES PROJECT SUPERVISOR CALIFORNIA STATE UNIVERSITY 5151 STATE UNIVERSITY DRIVE LOS ANGELES, CA 90032

LIMITED ASBESTOS SURVEY REPORT King Hall – Elevator Lobby

Date Prepared: April 18, 2018

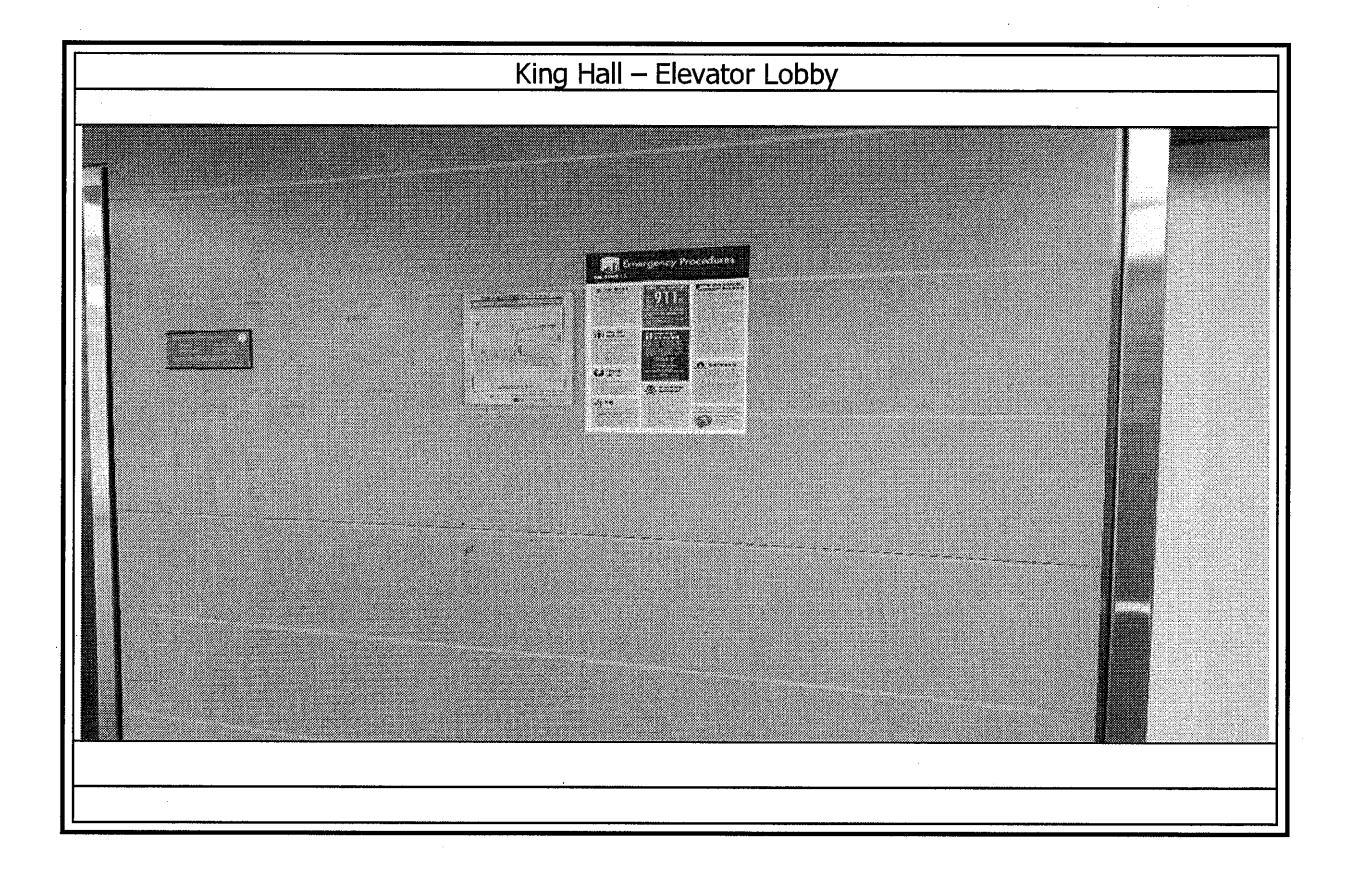
PHOTOGRAPHS

Homogeneous Material	Location	Lab Sample Numbers	Asbestos detected	Quantity
Brown Adhesive	Wall Behind Wood Paneling	180407001 180407002 180407003	None Detected	90 SF

Recommendations for handling ACCM: NONE

No Asbestos containing materials will be impacted by the renovation project activities.
