Venus Wind Turbine Optimization

Team Members: Grayson Hanes, Jesse Millan, Erick Mendoza, Jazmin Reyes, Eric Huang Faculty Advisor: Dr. Jim Kuo Jet Propulsion Laboratory Liaison: Dr. Jonathan Sauder Department of Mechanical Engineering College of Engineering, Computer Science, and Technology California State University, Los Angeles

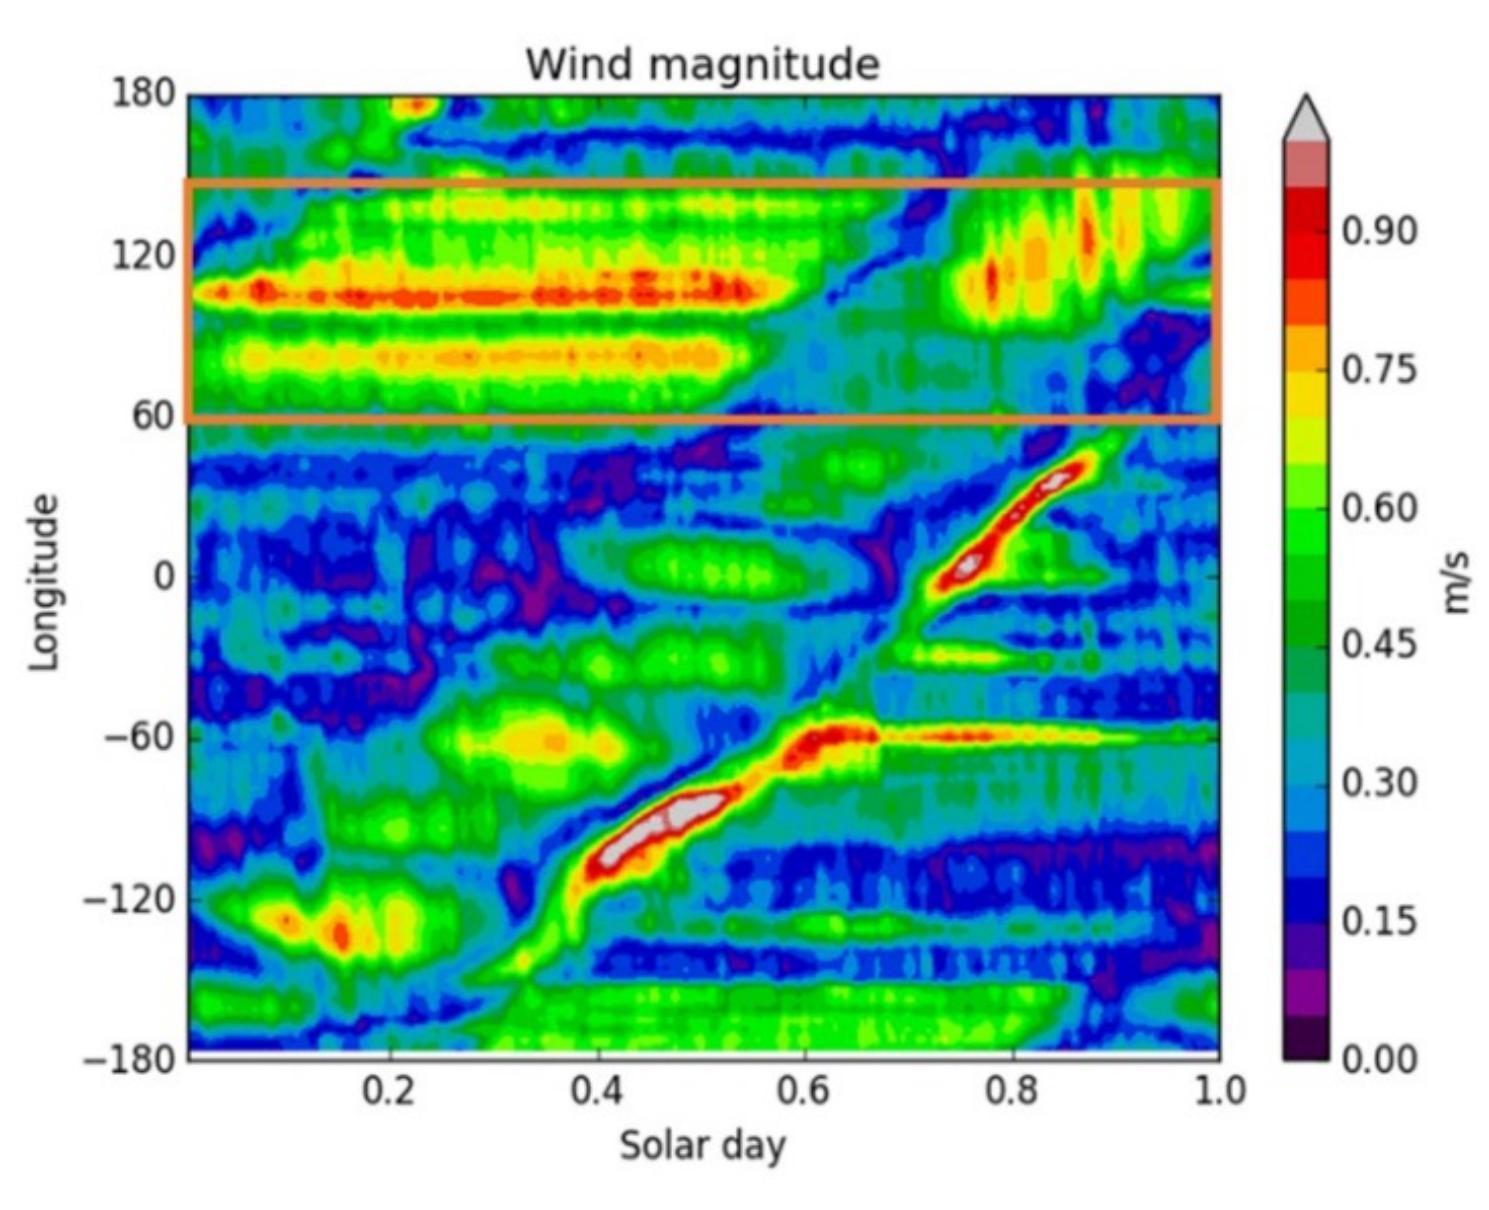
Figure 1 – Venus Wind Speeds

Venus is the second planet closest to the Sun and is often considered Earth's "sister" due to its size. However, Venus's environment is harsh and caustic. It has an average surface temperature of 460 C, a pressure of 9300 kPa, an air density of $67 \frac{kg}{m^3}$, and an average wind velocity of $0.7 \frac{m}{s}$. Wind velocity was obtained from multiple rover missions sent to Venus in the 1970s and 80s, shown in Figure 1 below.

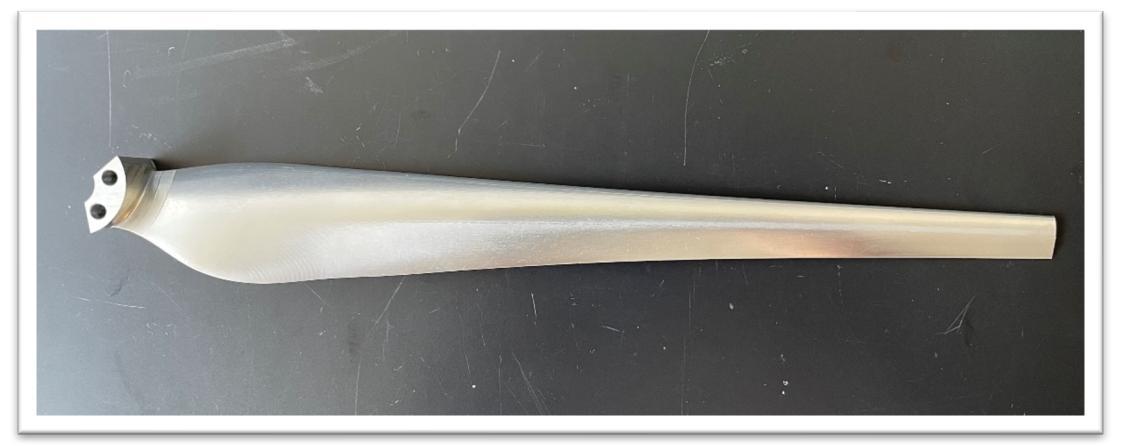
Figure 4 – 1/4th Scale Aluminum Turbine Blade

Blade Element Momentum Theory was applied to design the blade through a set of airfoils that satisfies the requirements of fluid properties and wind speed range. A 3-bladed system was then produced with 6061 aluminum for testing.

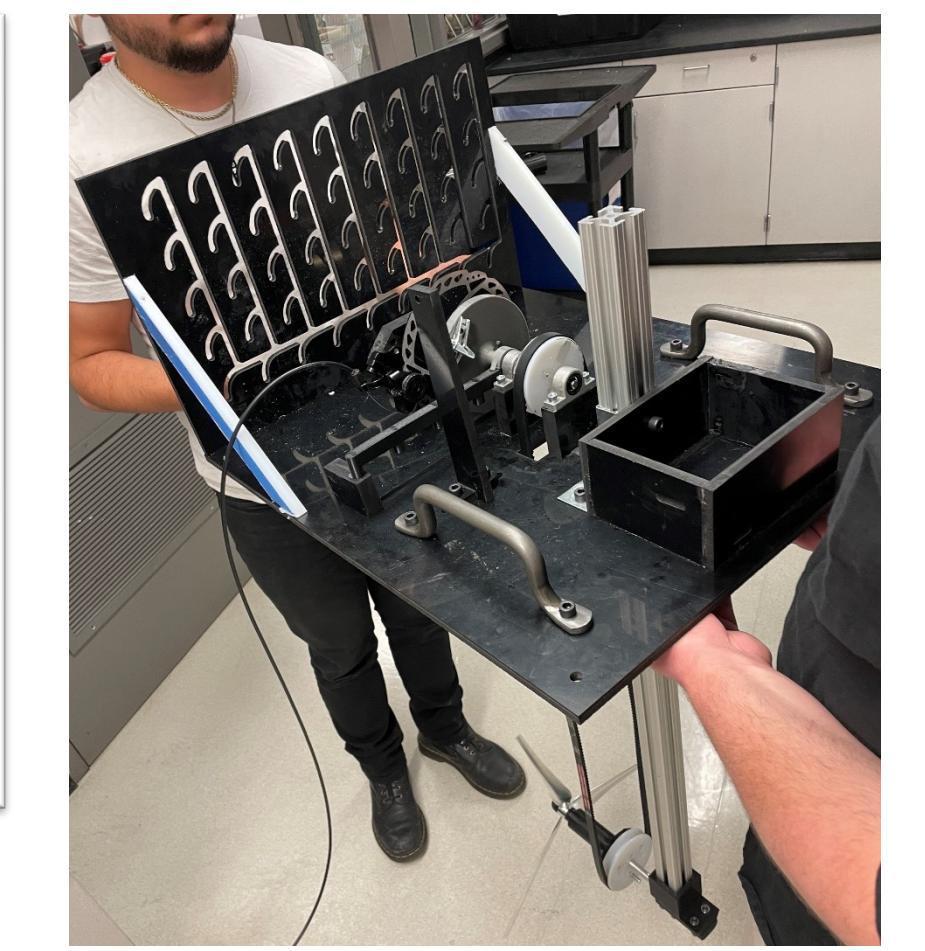
Figure 9 – Testing Platform

- Testing platform structure and components fabricated and assembled
- Various anomalies postponed system results
- The next step is to test the wind turbine in water to verify theoretical values
