**LIMITED ASBESTOS SURVEY REPORT
King Hall – Transite Pipe at North end
5151 State University Drive
Los Angeles, CA 90032**

Date Prepared: February 4, 2020

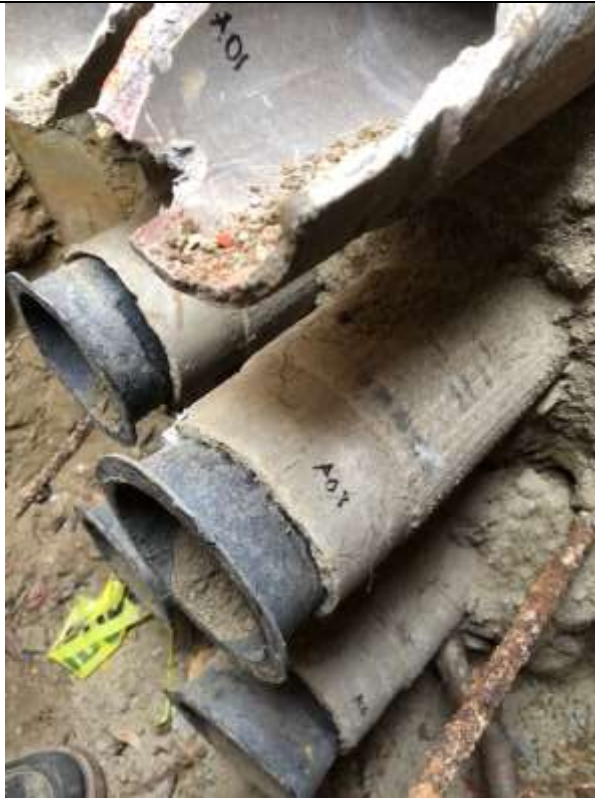
Homogeneous Material	Location	Lab Sample Numbers	Asbestos detected	Quantity
3" Transit Pipe	North Trench SW Corner	A01 A02 A03 A04 A05 A06	Chrysotile 17%-18% Crocidolite 2% - 3%	100 Ln. Ft.

ACM transite

Removal and disposal of Asbestos containing **3" Transit Pipe** must be performed by a California Licensed Asbestos Abatement Contractor, in accordance with all applicable regulations, including but not limited to, 29 CFR 1926.1101 (OSHA), 40 CFR 763 (AHERA), 40 CFR Part 61 (NESHAPS) and 8 CAC 1529 (Cal/OSHA Asbestos), including mandatory and non-mandatory appendices as applicable, and Local Air Quality Management District regulations (SCAQMD 1403).

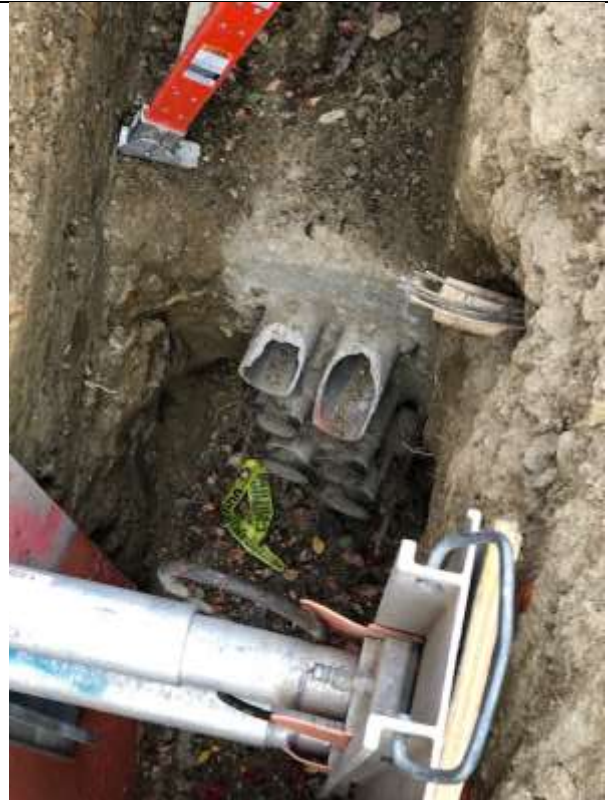
Underground utilities
